TECHNICAL REPORT EL-80-4

AREA STRIP MINE RECLAMATION USING DREDGED MATERIAL: A FIELD DEMONSTRATION

Eugene R. Perrier, Jose L. Llopis, Patricia A. Spaine

Environmental Laboratory
U. S. Army Engineer Waterways Experiment Station
P. O. Box 631, Vicksburg, Miss. 39180

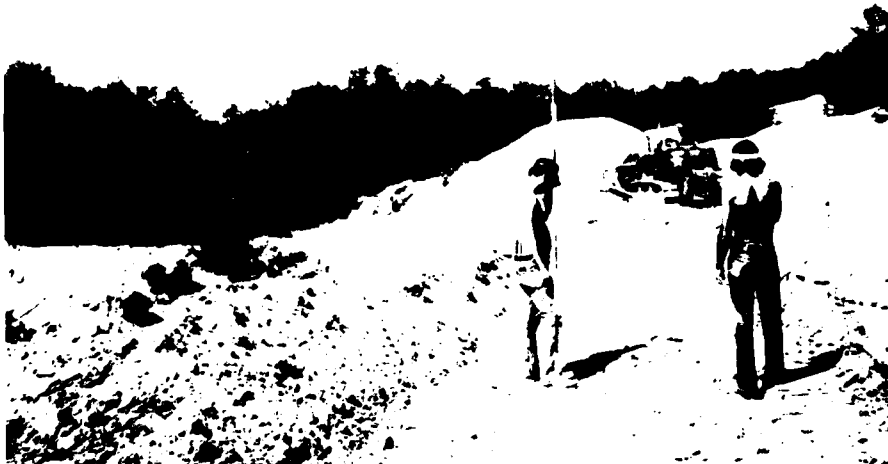
Figure 22. Leveling mine spoil ridges

47. The demonstration site consisted of a series of northwest-southeast trending parallel ridges as shown in Figure 21. The site was constructed as shown in Figure 22 by leveling a section of the center two ridges with dozers and forming a raised plateau. The 5-ft-high dikes were constructed from mine spoil and covered with heavy-duty polyvinyl chloride (PVC) plastic. The purpose of the dikes was to separate the plots and segregate the surface runoff from each plot for monitoring activities (Figure 20).

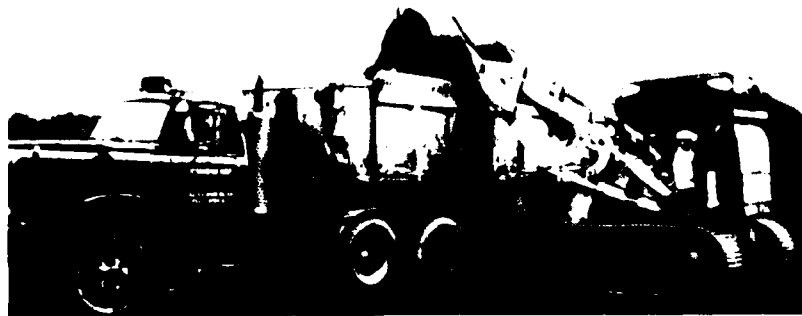
Figure 24. Loading dredged material at borrow area

49. The stockpiled dredged material was loaded by a front-end loader onto trucks, whose capacity was approximately 15 yd³, and hauled to the test site (Figure 24). The Corps used the truck haul method for transporting the dredged material in preference to the seemingly more economical barge haul method because of simplicity and timeliness.³ Crushed agricultural limestone was spread, as shown in Figure 25, and then disked into the mine spoil in plots III and IV. The dredged material was placed in plots II, III, and IV to the 3-ft depth. A dozer then spread the material to the specified depth of 3 ft (Figure 26) and the finished surface was graded with a front-end loader to the southwest corner of each plot at a grade of approximately 0.5 percent.

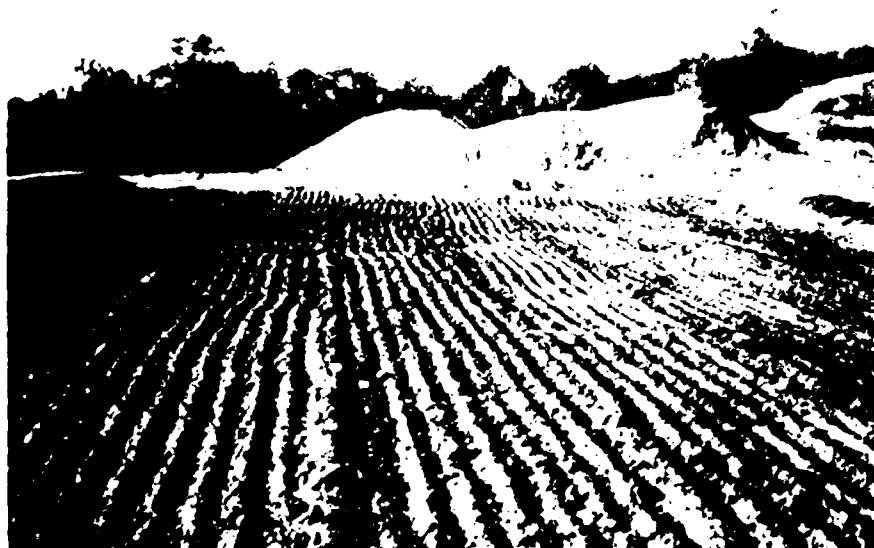
Figure 27. Plot IV scarified and prepared for seeding

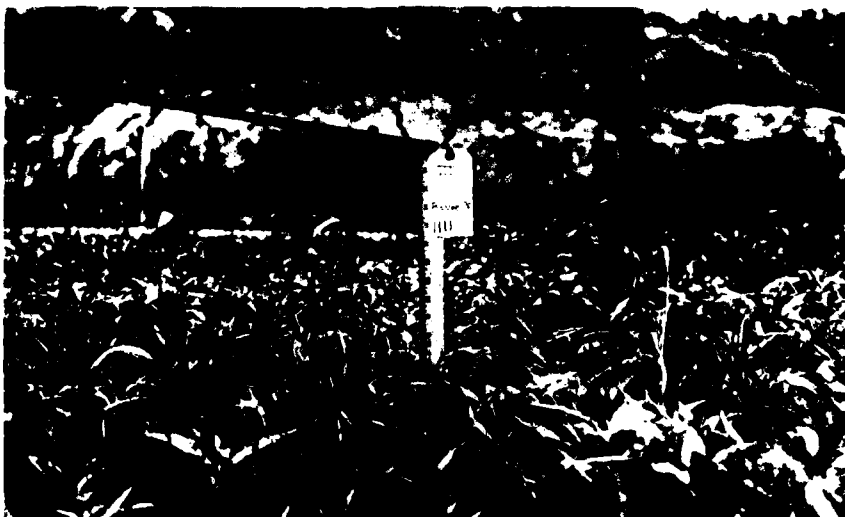
Figure 36. Photograph of vegetative growth of seed mixture on plot III as of 8 June 78

64. The height of the plants as of 8 June 1978 is shown in Figures 34-37. In control plot I, the seed mixture did not germinate and only an occasional grass or weed appeared to be growing in the plot. Plots II, III, and IV produced an excellent cover that was about 8 in. in height as of 8 June 1978. Some of the broad leaves present in the plots were smartweed (Polygonum lapathifolium), an invading species particularly attractive to wildlife, and an occasional head of wheat (the seed was carried in the straw mulch).
